IMAGES FROM WELLINGTON SEWER CAMERA LOGS

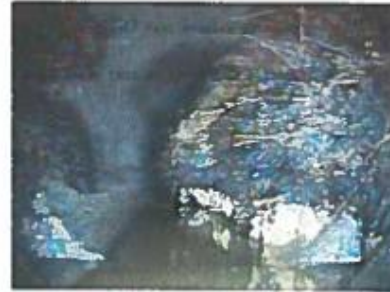
136.9	Root	Yes	/	Moderate	HAD TO STOP HERE DO TO ROOTS AND BEYOND ROOTS IS WERE THE STUB IS BUT HAS BEEN BROKEN AND NOW THE DIRT IS EXPOSED

CANNOT CUT

211.9	15.2	Sag	No	/	Minor	
286.6		Root-in-Joint	No	/	Severe	THIS IS TOP END OF ROOT MASS
286.6		STOP	No	/

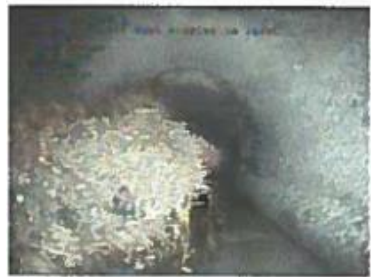
148.2	Root-in-Joint	Yes	/	Severe	
-------	---------------	-----	---	--------	--

149.2	Root-in-Joint	Yes	/	Severe	HAD TO STOP DUE TO ROOTS. NEEDS TO BE CUT OUT. WE WILL TRY TO TV FROM TOP END AND COME DOWN TO THIS POINT
-------	---------------	-----	---	--------	---

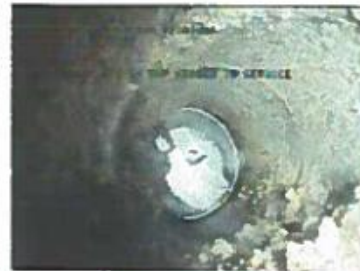
9.4	Lateral	No	10 /			
9.4	Lateral Connection Problem	No	/	Lateral Blocked	Severe	BROKEN CAP WEDGED IN SERVICE

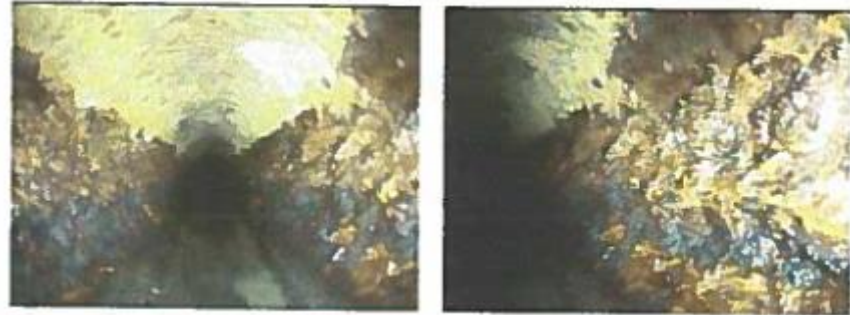
Distance	Length	Code	Reversed	Clock Pos.	Severity	Comment
8.0	FLOW	Surface Damage	Yes	/	Moderate	
22.5	Surface Damage	Yes	/	Moderate	HAD TO STOP HERE DUE TO BUILD UP, AND ALREADY TRY TO TV DOWN FROM TOP. TOTAL SECTION LENGTH IS 207

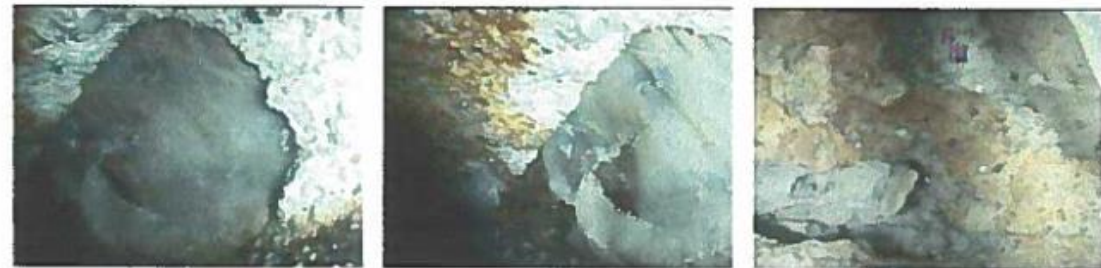
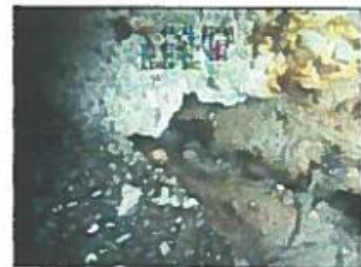
Distance	Length	Code	Reversed	Clock Pos.	Severity	Comment
2.0	START WITH FLOW	No	/			
2.0	Hole	No	/	Forming Cavity	Severe

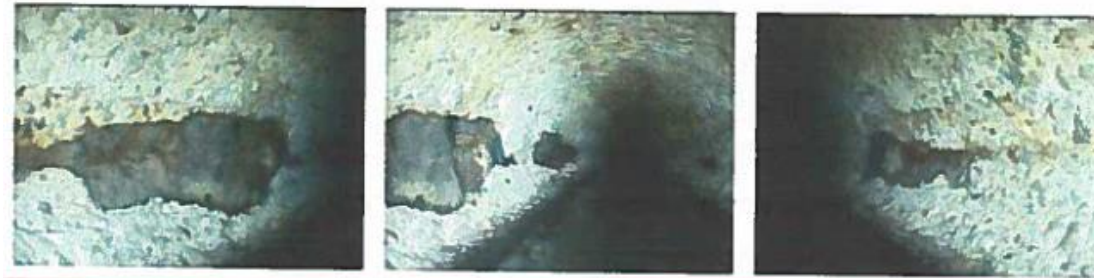
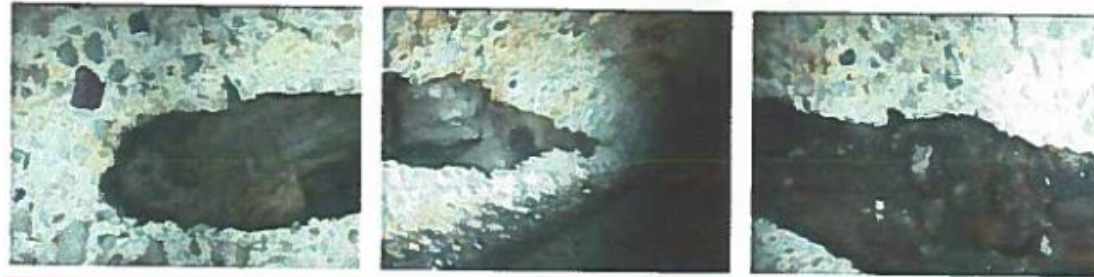
Distance	Length	Code	Reversed	Clock Pos.	Severity	Comment
5.8	393.2	Surface Damage	No	/	Moderate	Severe
					Material Damage - Chemical

Distance	Length	Code	Reversed	Clock Pos.	Severity	Comment
25.9	Hole	No	/	Problem Forming Cavity	Severe	
36.2	Cavity	No	/	Severe		
36.2	Hole	No	/	Forming Cavity	Severe	
51.0	Hole	No	/	Forming Cavity	Severe

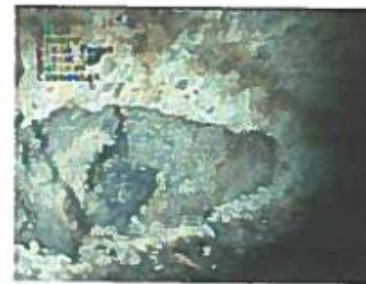
Distance	Length	Code	Reversed	Clock Pos.	Severity	Comment
167.0	Hole	No	/	Severe
